Wascana Centre Authority

Comprehensive Review Project

Building and Infrastructure Assessments

September 2012

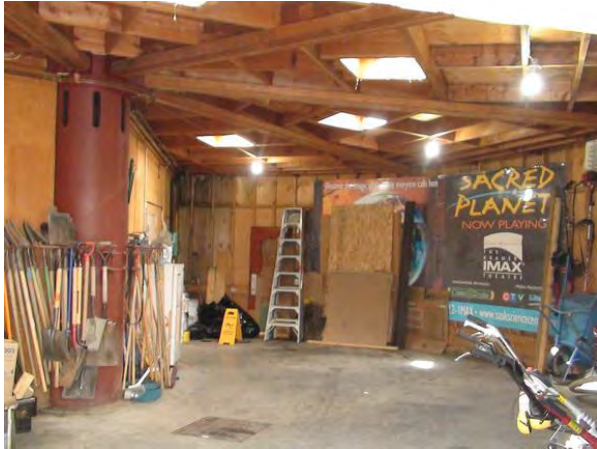
Goose Hill-Interior-Overview

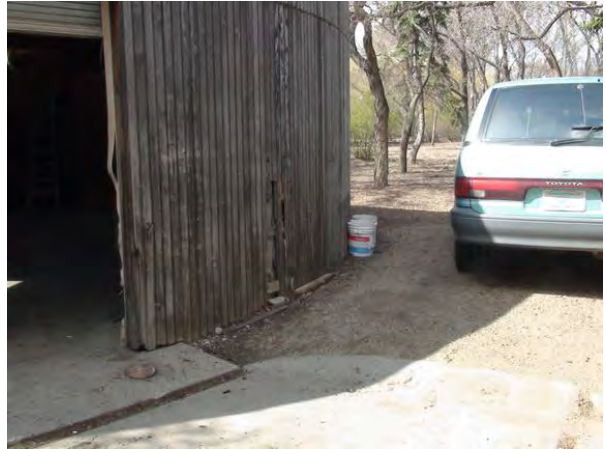
Overhead Exterior Doors-Detail-Envelope

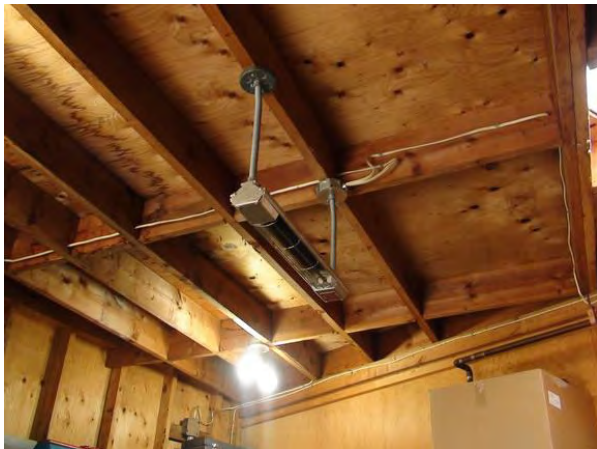
Radiant Heaters-Detail-Interior

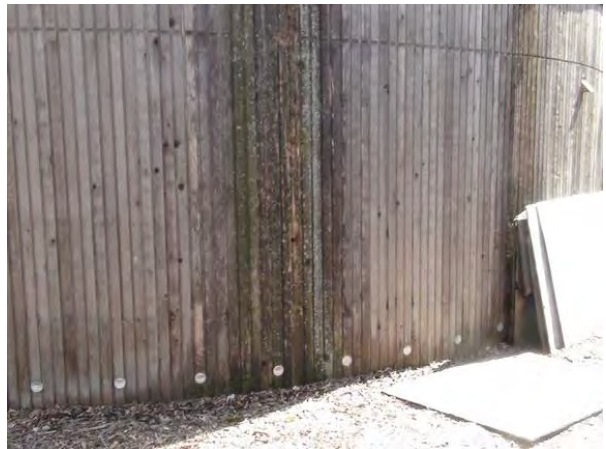
Wood Clad Exterior Walls-Detail-Envelope

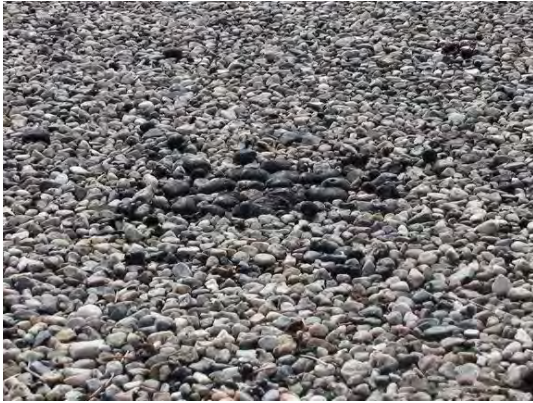
Bituminous Roofing1-Detail-Exterior

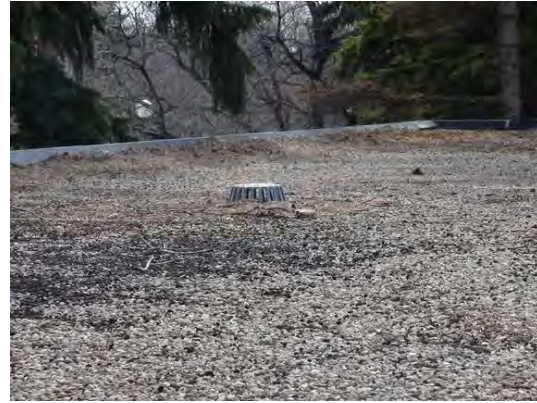
Bituminous Roofing2-Detail-Exterior

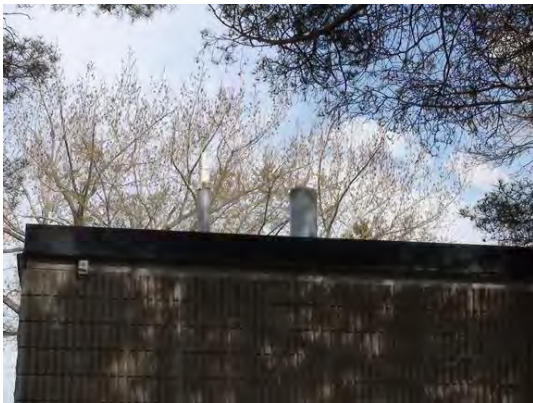
Chimney Raincap-Detail-Exterior

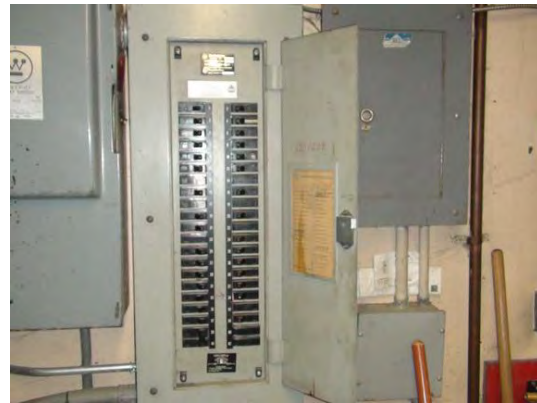
Circuit Panelboard1-Detail-Interior Electrical

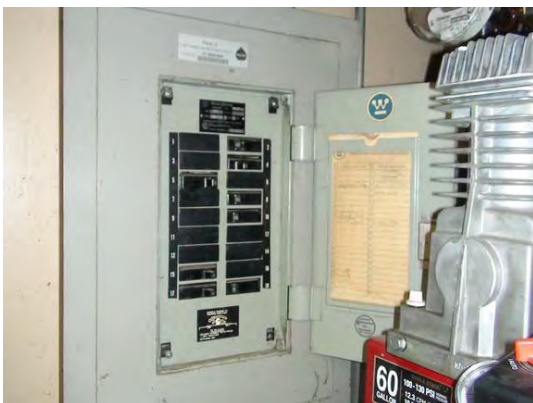
Circuit Panelboard2-Detail-Interior Electrical

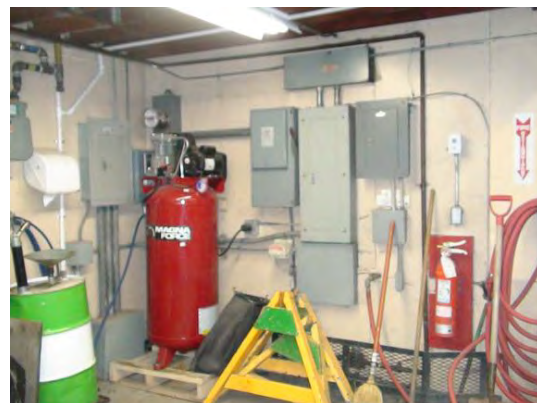
Electrical Service-Detail-Interior Distbn

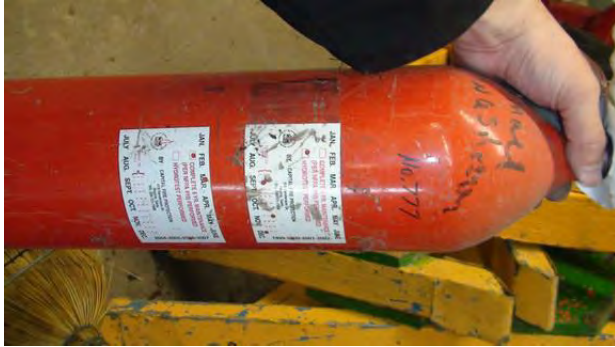
Fire Extinguisher-Detail-Interior

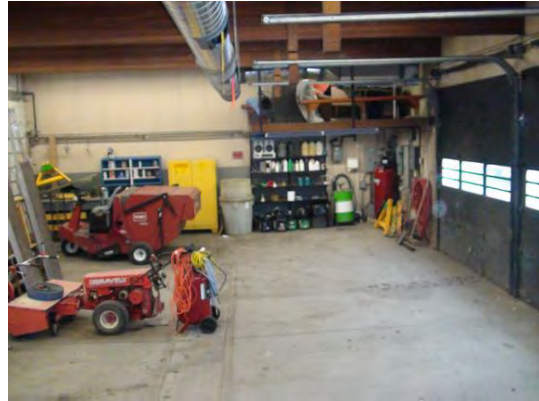
Floor Drains-Detail-Interior

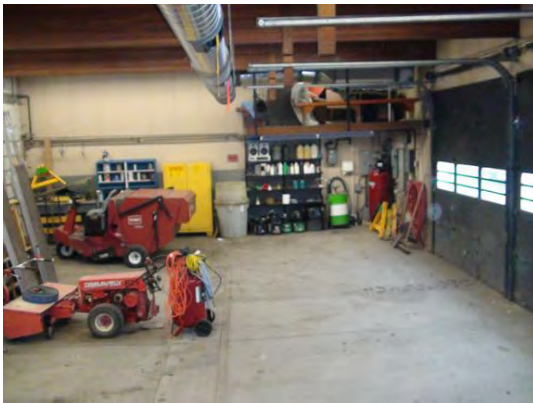
Mezzanine-Detail-Interior

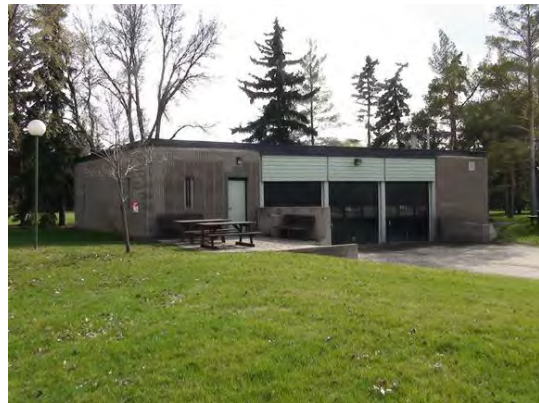
Service Depot - Overview

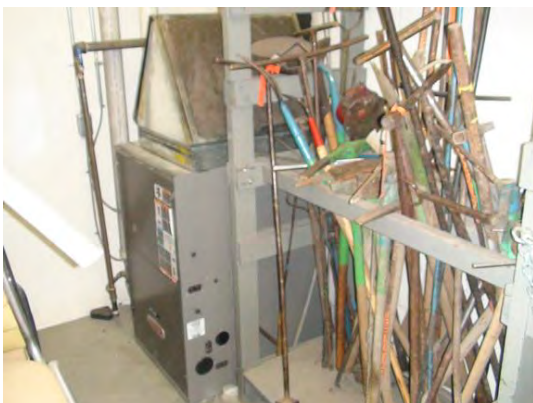
Standard Furnace-Detail-Interior

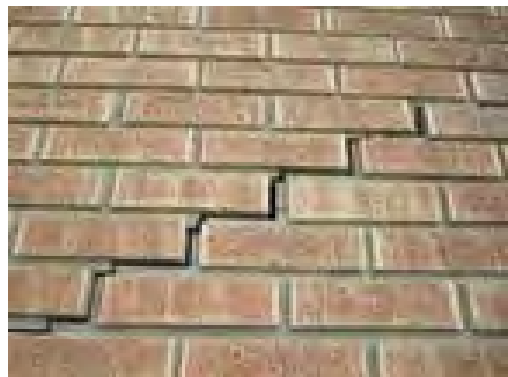
Ext Brick Wall Detail - West

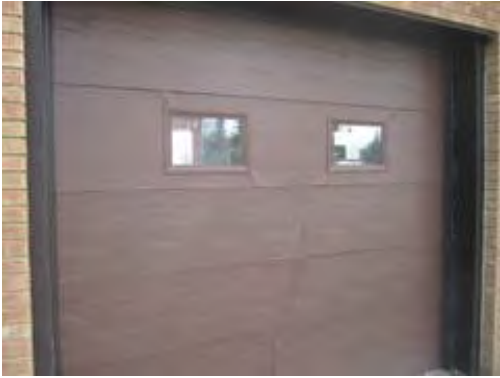
Ext Composite OH Door - West

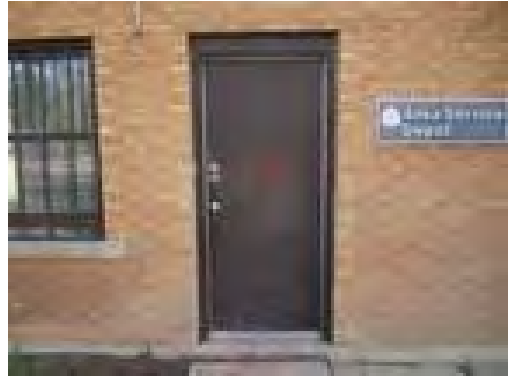
Ext Steel - West

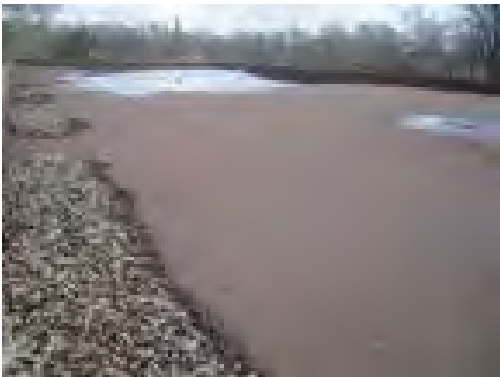
Modified Bituminous Membrane - Roof

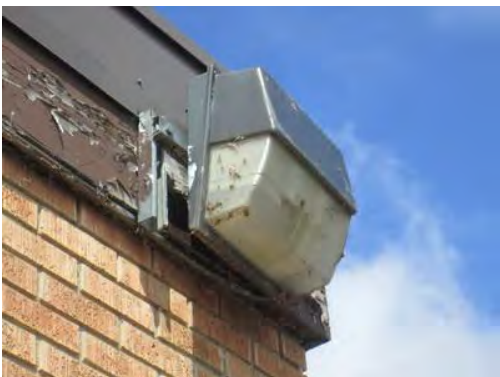
Ext HID Lighting Detail - East

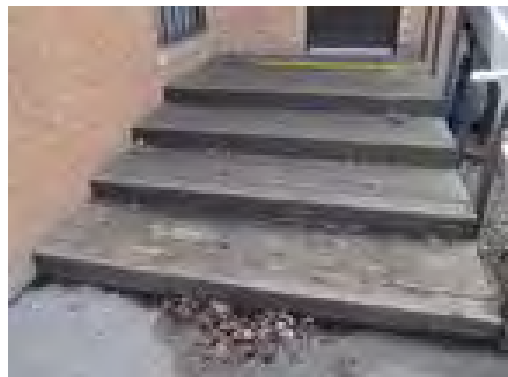
Ext Wood Stairs - West

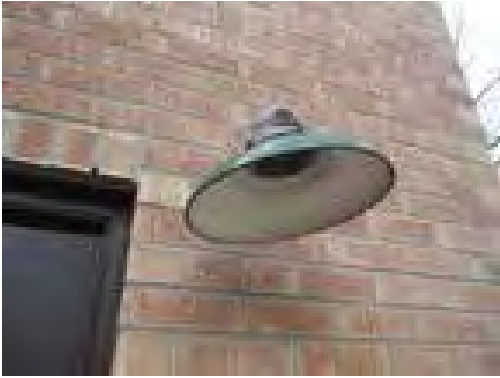
Incandescent Lighting - West

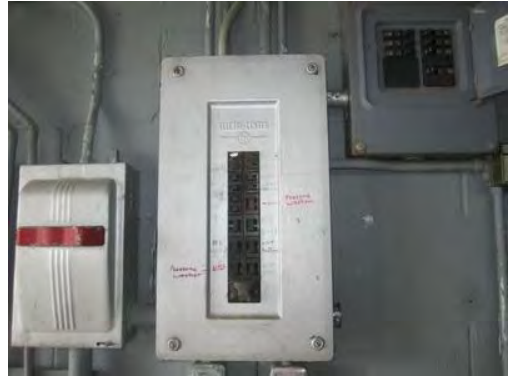
Circuit Panel - Garage

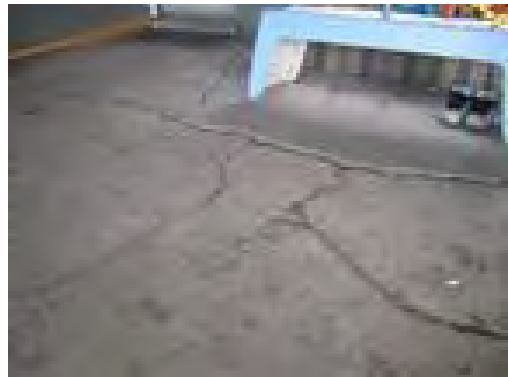
Concrete Floor Detail - Internal Shop Area

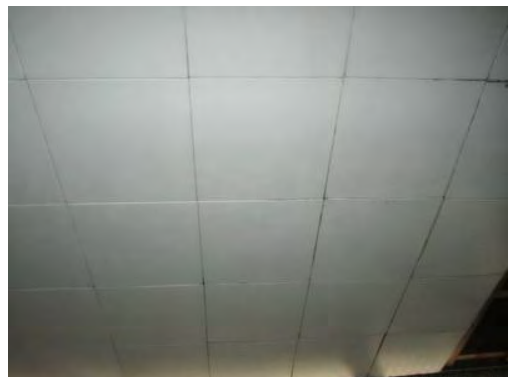
Fixed Ceiling Tile - Staff Lounge Locker Room

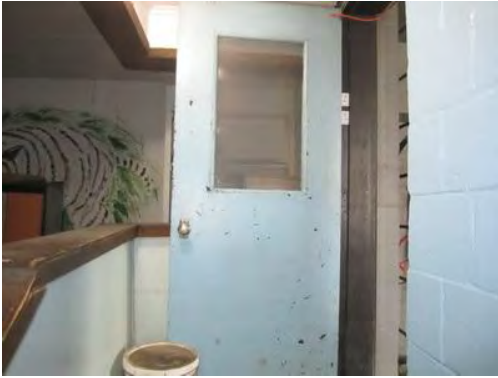
Internal Wood Door - Staff Lounge Locker Room

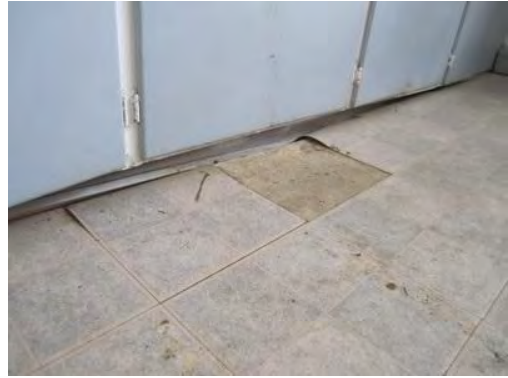
Linoleum Flooring Detail - Staff Room

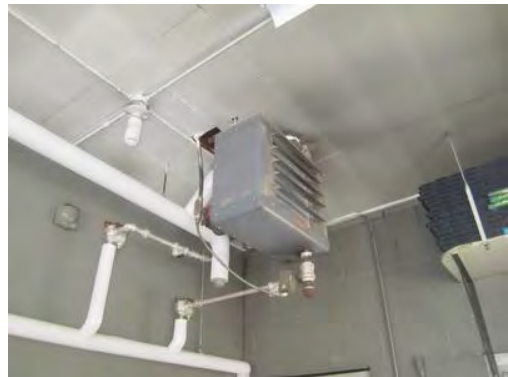
Unit Heater (Trane) - Internal Shop Area

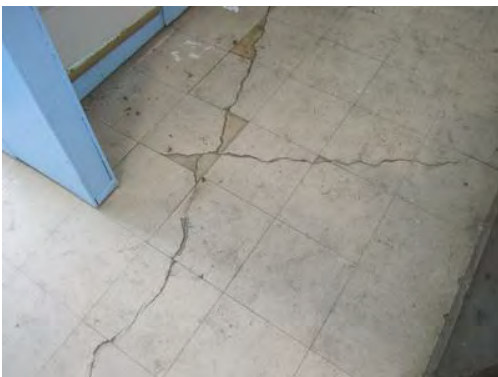
VCT Flooring Detail - Staff Lounge Locker Room

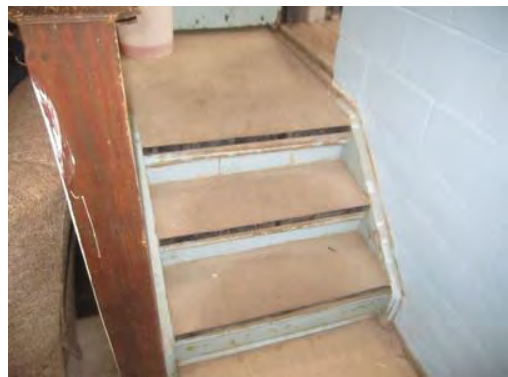
Wooden Stairs - Staff Lounge Locker Room

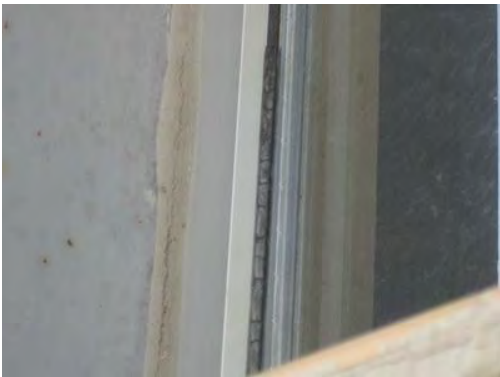
Ext Aluminum Window - Exterior

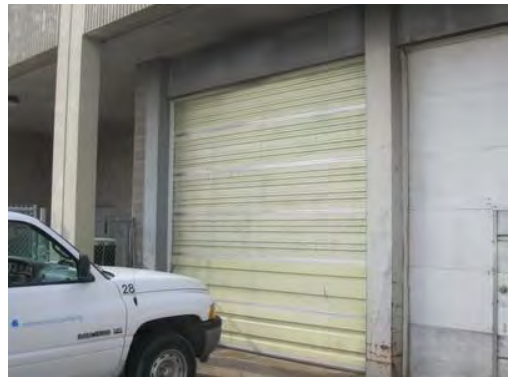
Ext Overhead Door (Plastic) - Exterior

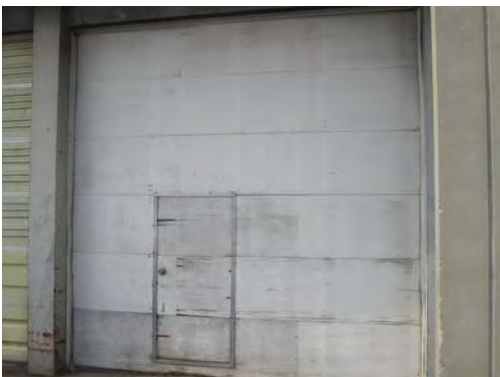
Ext Overhead Door (Wood) - Exterior

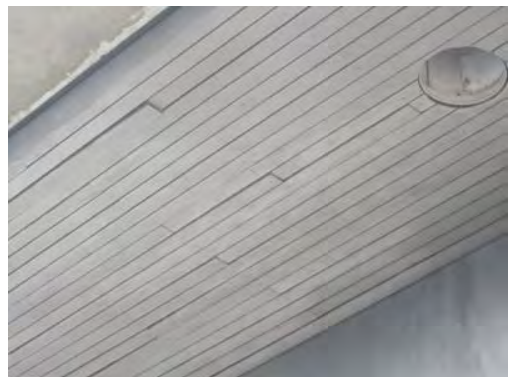
Wood Soffits - Exterior

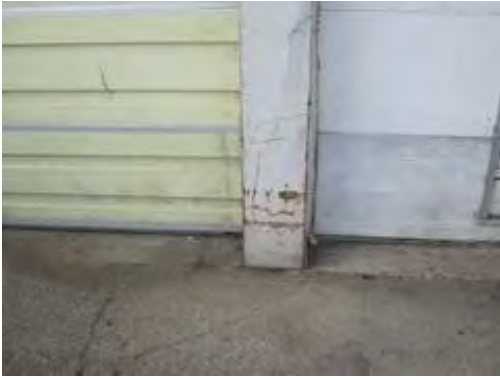
Steel Column Detail - Exterior

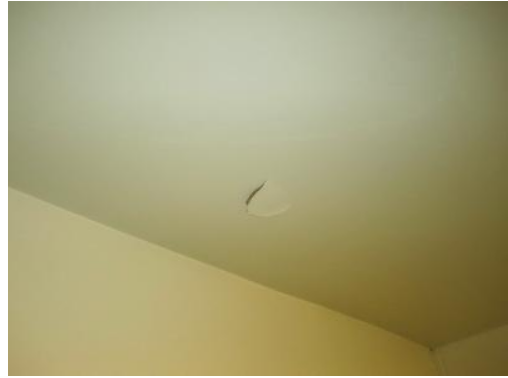
GB Ceiling - Womens Washroom

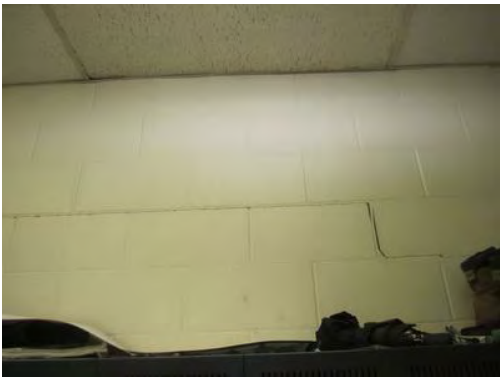
Int CMU Wall - Locker Room

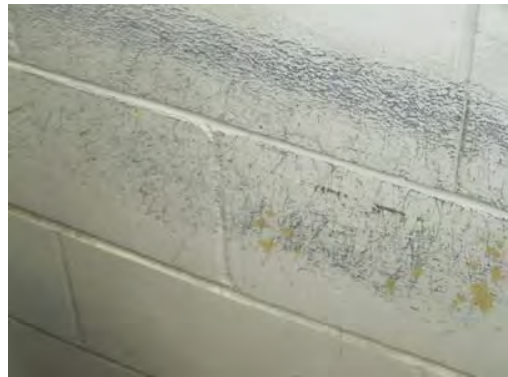
Int CMU Wall Detail - Parts Room 138

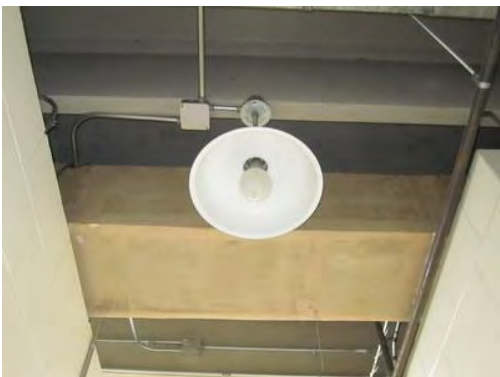
Int Incandescent Light

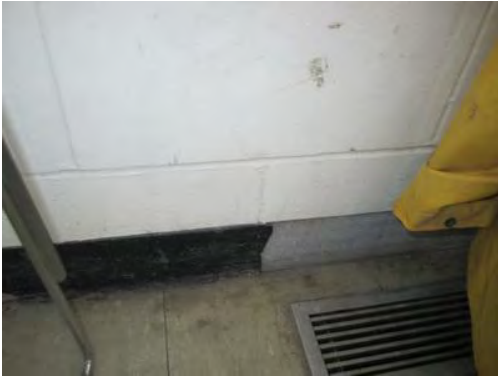
Rubber Cove Base - Staff Room 140

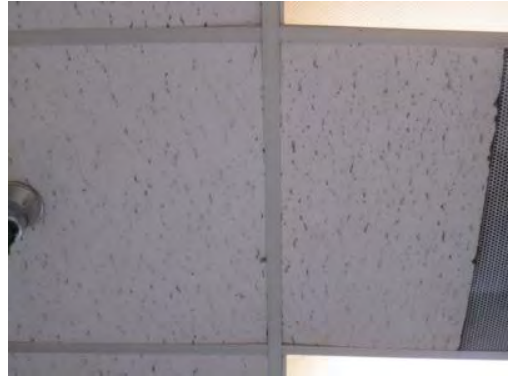
Suspended ACT - Parts Room 138

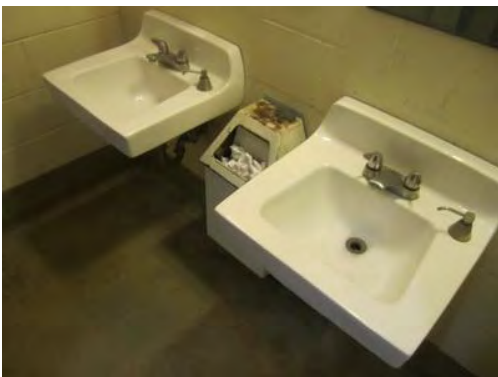
Vitreous China Sinks - Men's Washroom

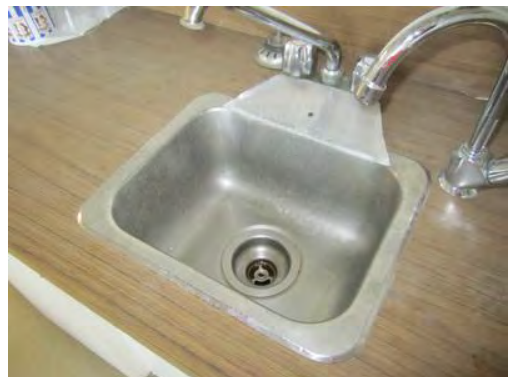
Stainless Steel Sink - Staff Room 140

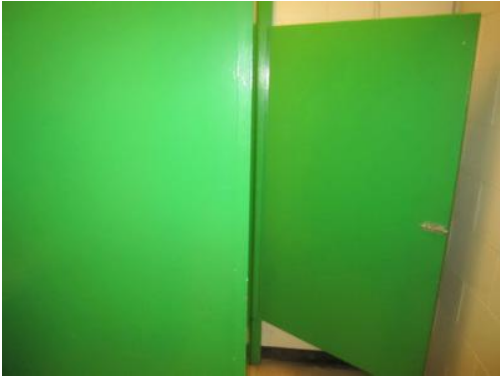
WR Partition - Men's Washroom

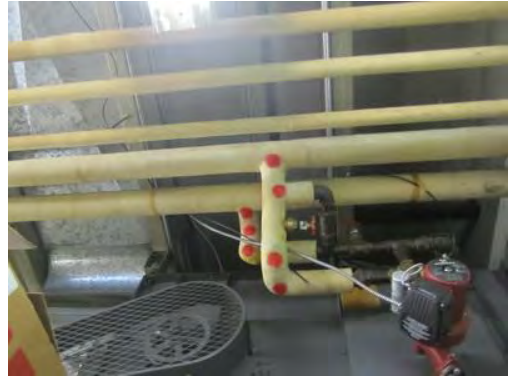
Asbestos Pipe Wrap - Parts Room 138

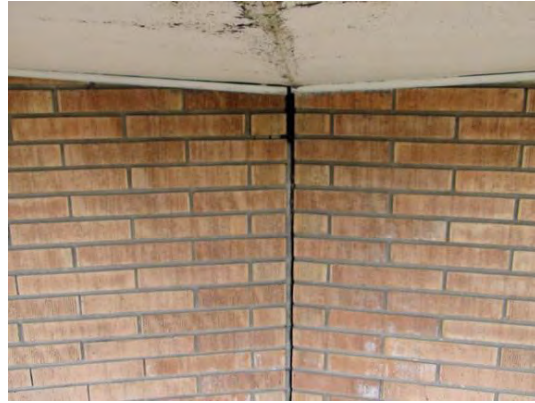
Brick Wall Joint-Detail-Exterior

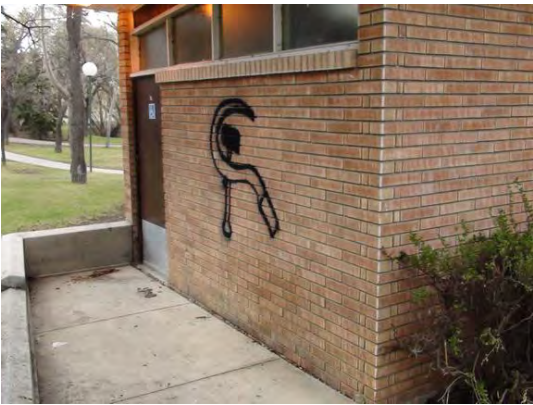
Brick Wall-Detail-Exterior

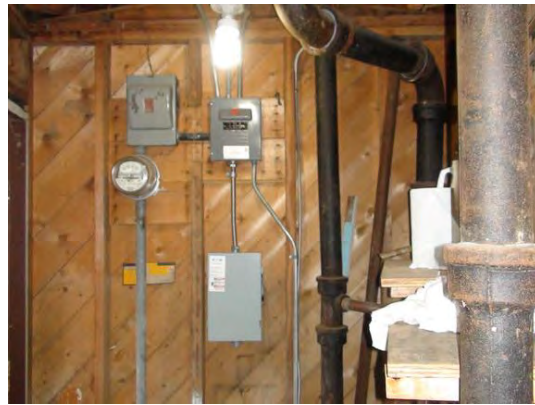
Circuit Panelboards-Detail-Interior

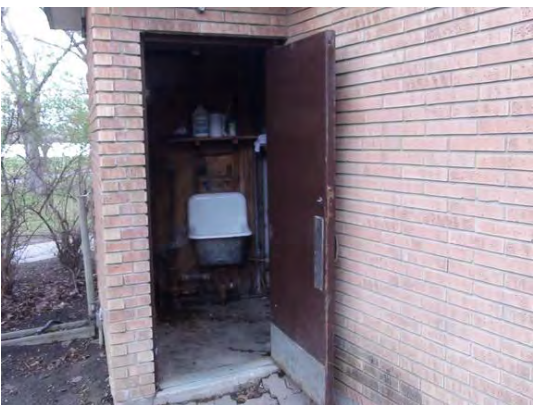
Door-Detail-Exterior

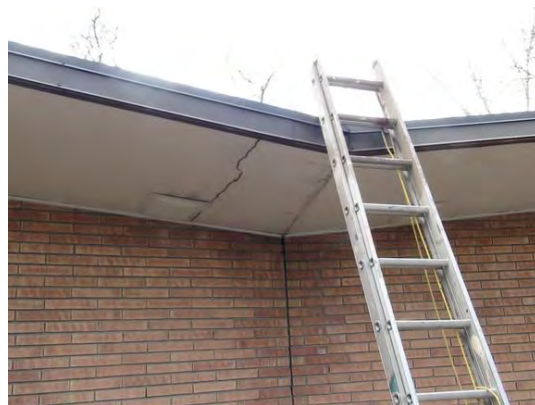
Roof1-Detail-Exterior

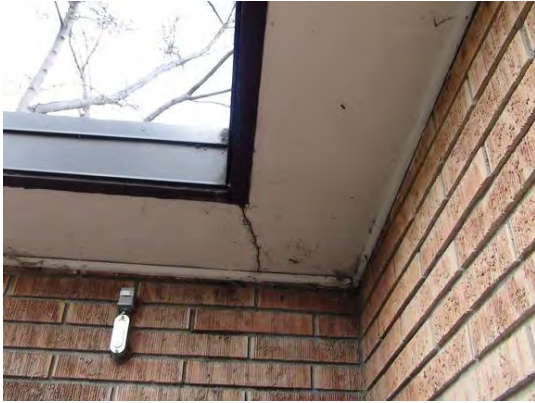
Roof2-Detail-Exterior

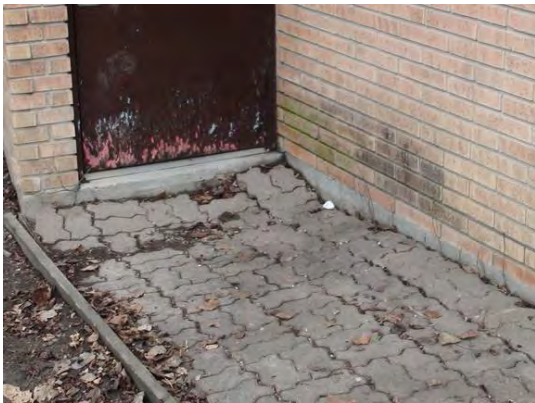
Structural Slab-Detail-Exterior

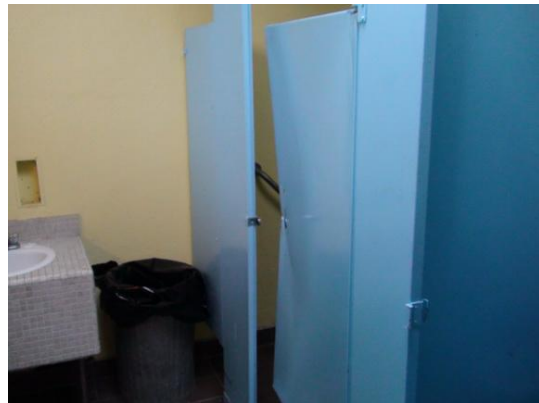
Washroom Partition-Detail-Interior

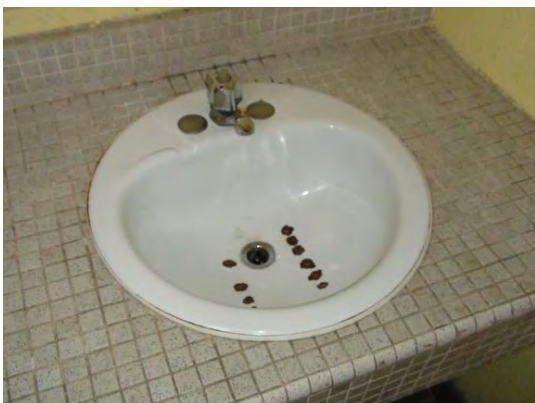
Washroom Sink-Detail-Interior

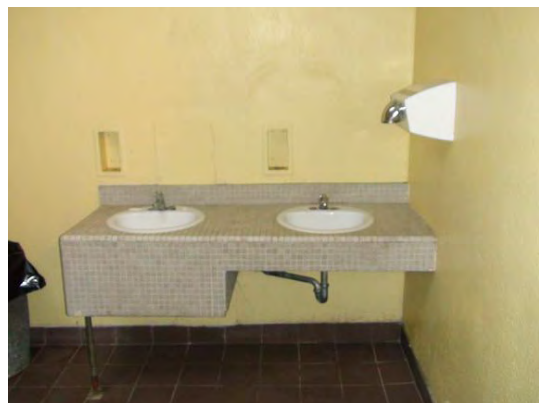
Washroom Sinks-Detail-Interior

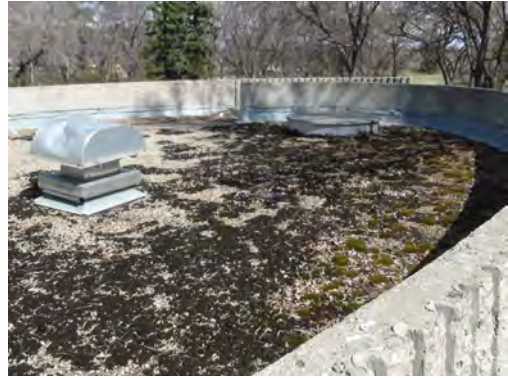
Bituminous Roofing-Detail-Exterior

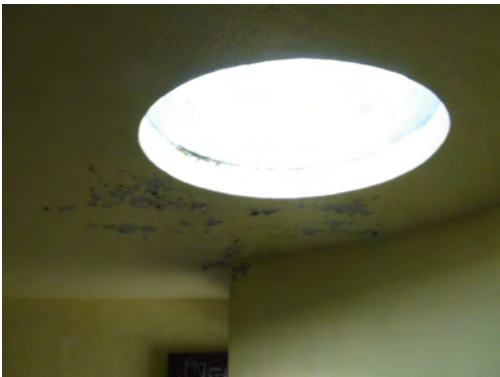
Ceiling Finish-Detail-Interior

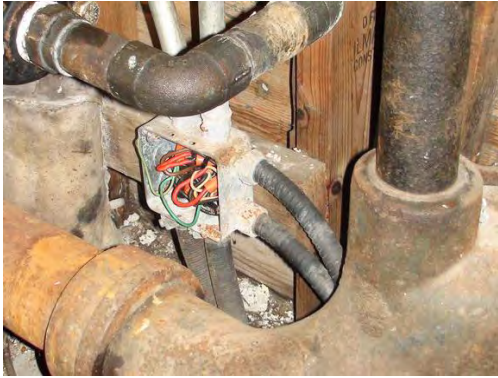
Branch Wiring-Detail-Interior

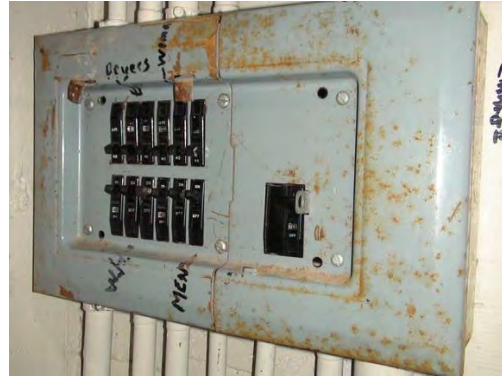
Circuit Panelboards-Detail-Interior

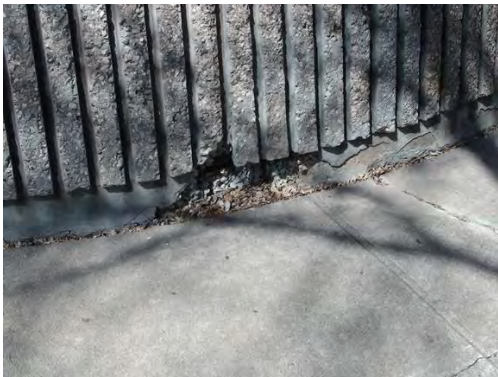
Concrete Wall Panel SW-Detail-Exterior

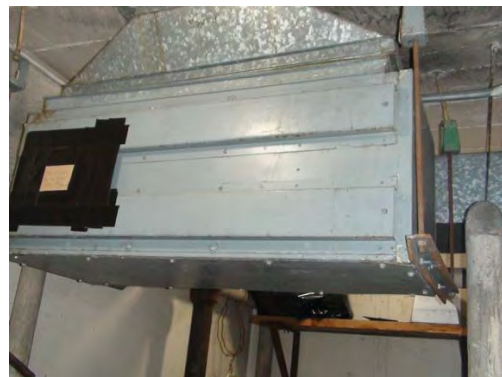
Exhaust Fan-Detail-Interior

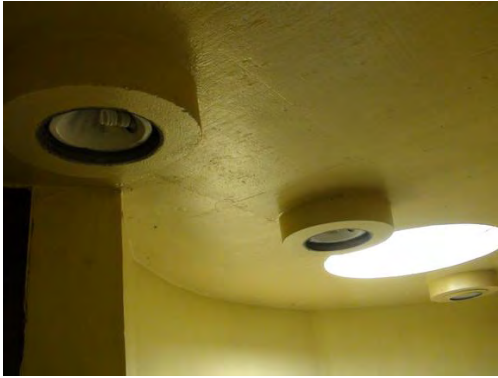
Incandescent Fixture-Detail-Interior

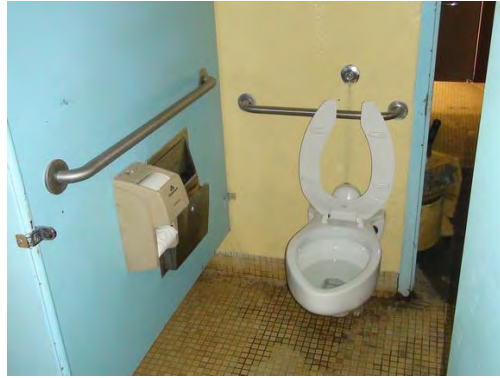
Tile Floor-Detail-Interior

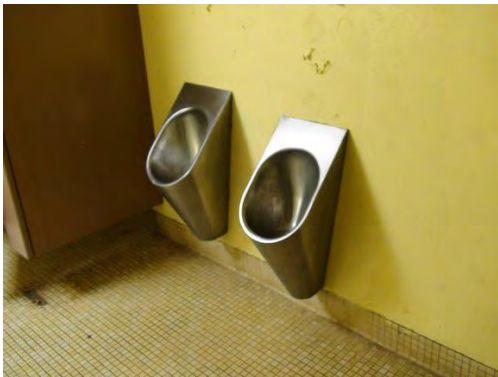
Urinal Steel Fixture-Detail-Interior

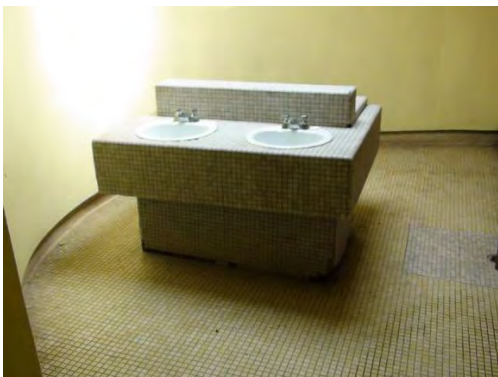
Washroom Sink-Detail-Interior

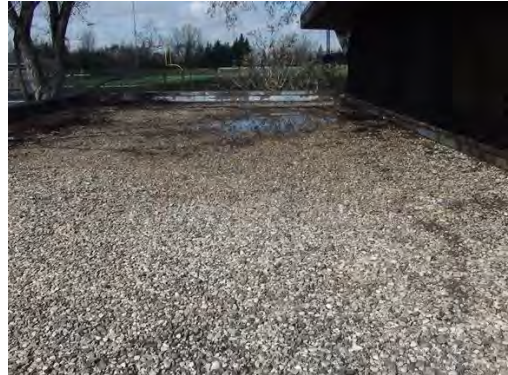
Bituminous Roofing-Detail-Exterior

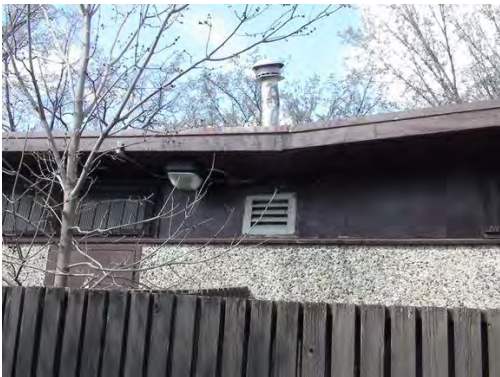
Chimney-Detail-Exterior

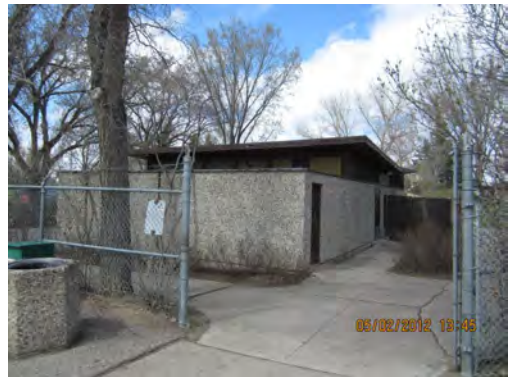
Wall Exposed Aggregate-Detail-Exterior

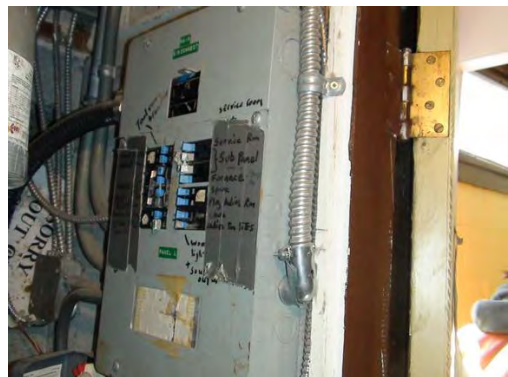
Circuit Panelboards-Detail-Interior

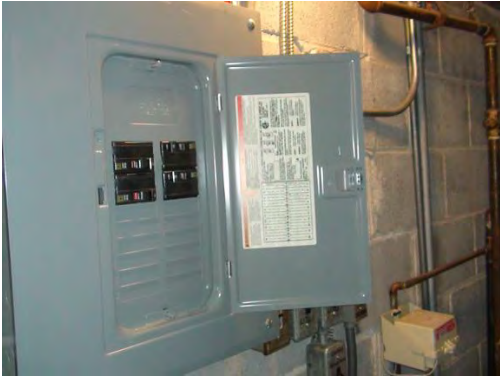
Circuit Subpanelboard-Detail-Interior

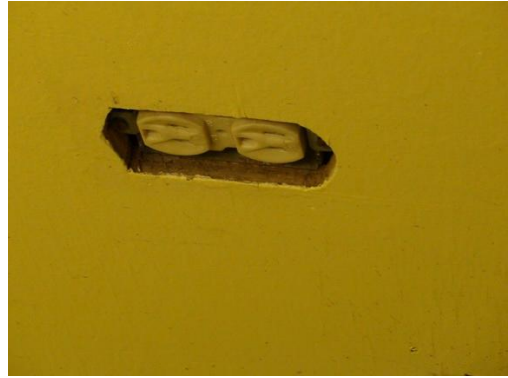
Electrical-Detail-Interior

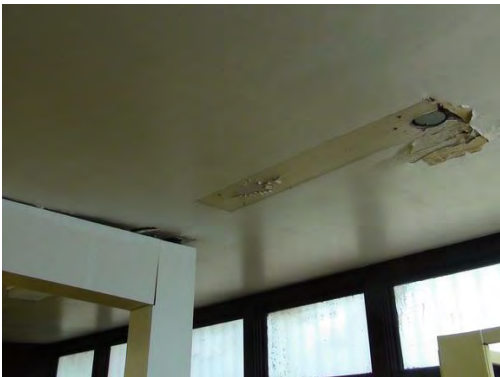
Gypsum Ceiling-Detail-Interior

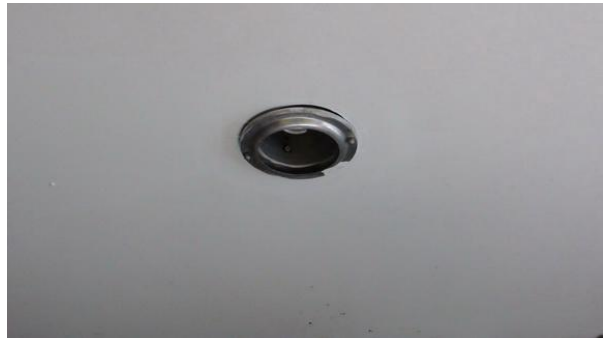
Incandescent Fixture-Detail-Interior

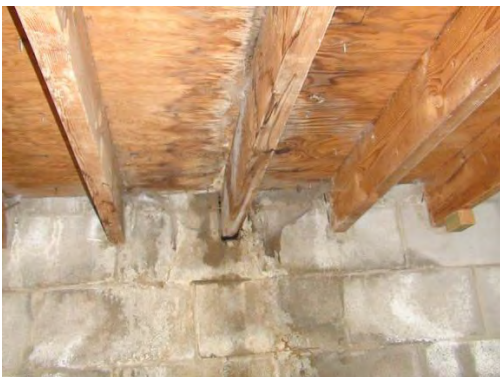
Roof Construction-Detail-Interior

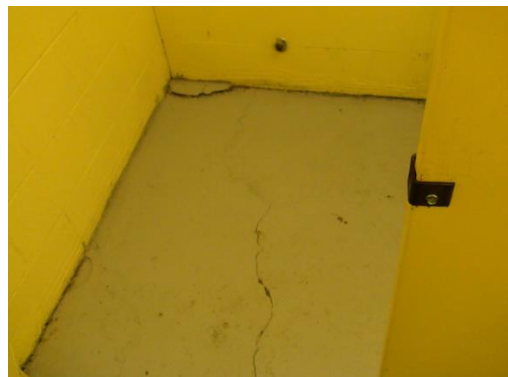
Standard Slab Grade corner-Detail-Interior

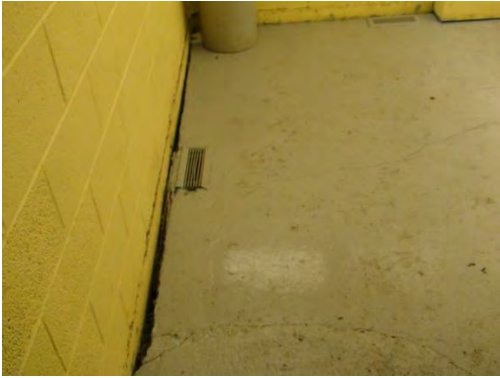
Standard Slab Grade-Detail-Interior

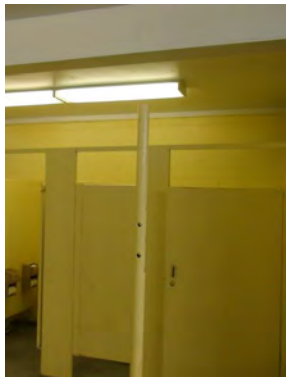
Structural Support-Detail-Interior Mens

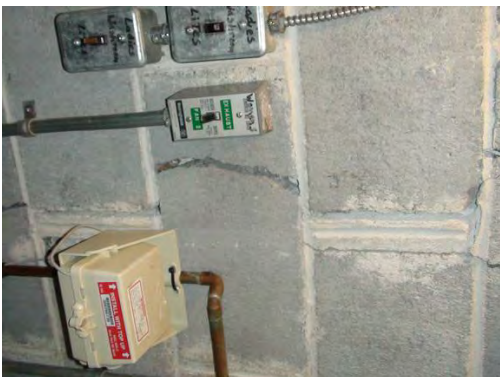
Structure Support Roof2-Detail-Interior

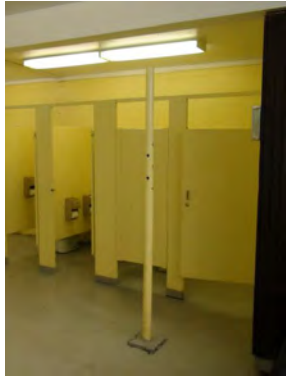
Structure Support Roof telepost-Detail-Interior

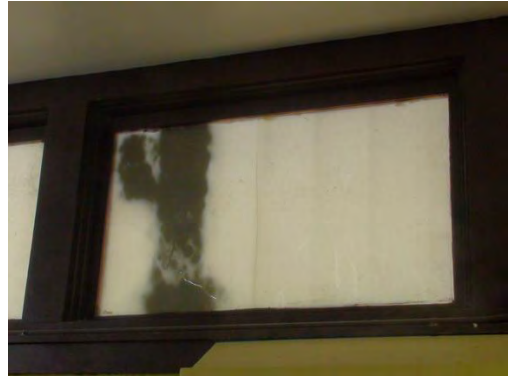
Window-Detail-Interior

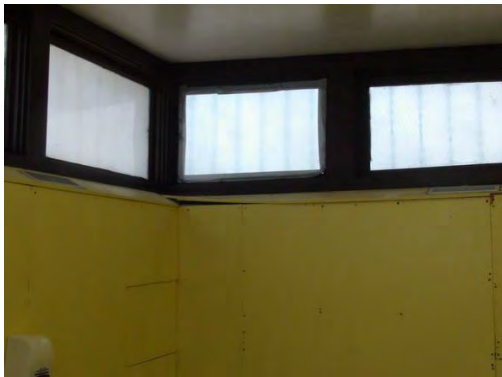
Windows-Detail-Interior

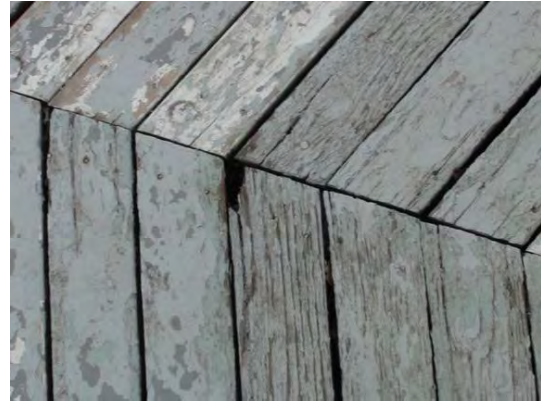
Deck Floor-Detail-Exterior

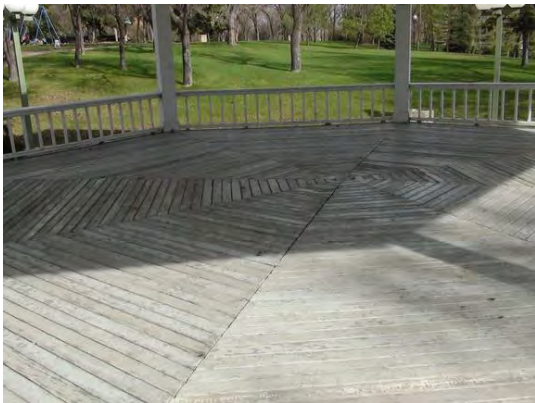
Overall Deck Floor-Detail-Exterior

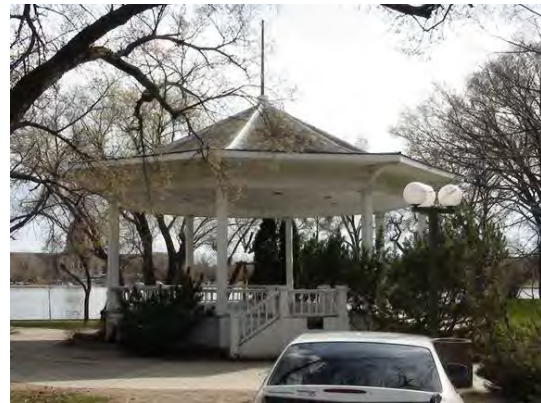
Stairs&Handrails-Detail-Exterior

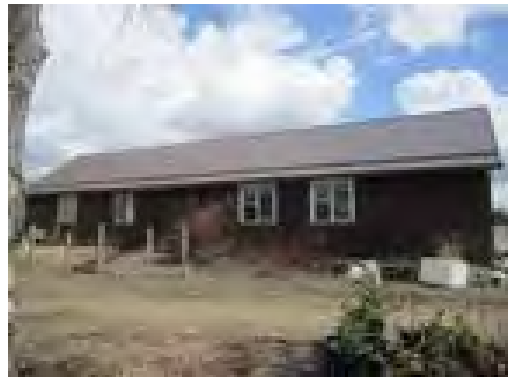
West Elevation

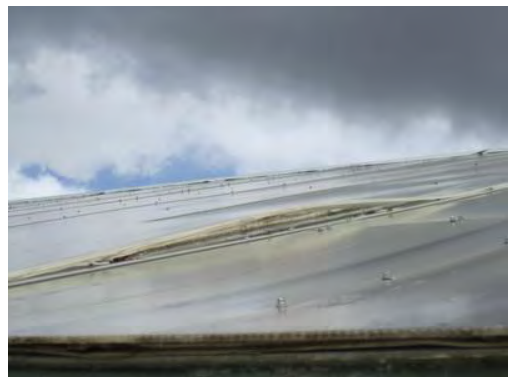
Acrylic Roof Detail - East

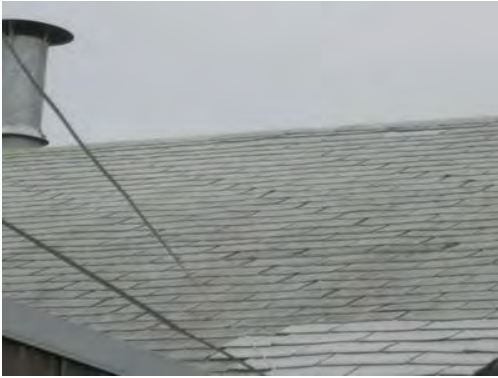
Asphalt Shingles - Roof

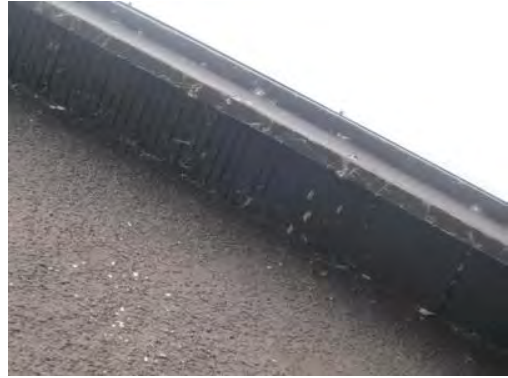
Ext Wood Soffit - North

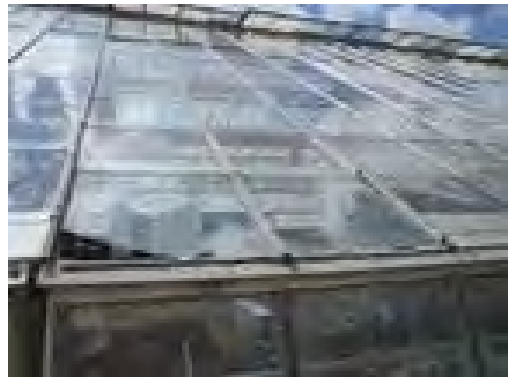
Ext Glazing Detail - East

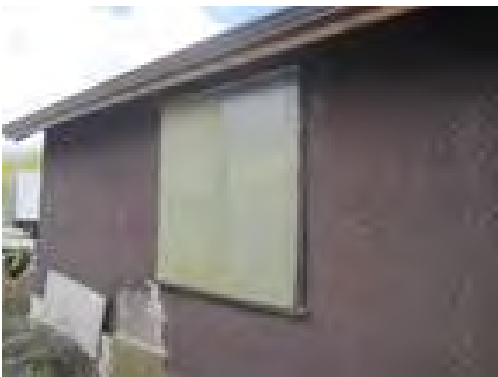
Ext Wood Window - South (2)

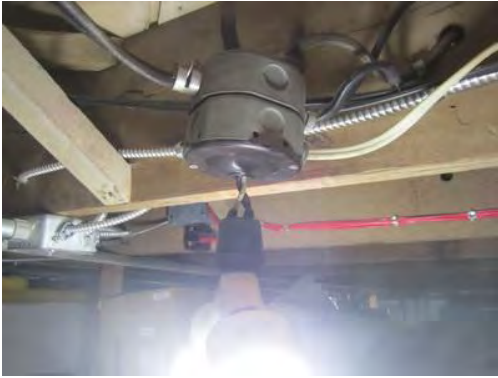
Branch Wiring Detail - Basement

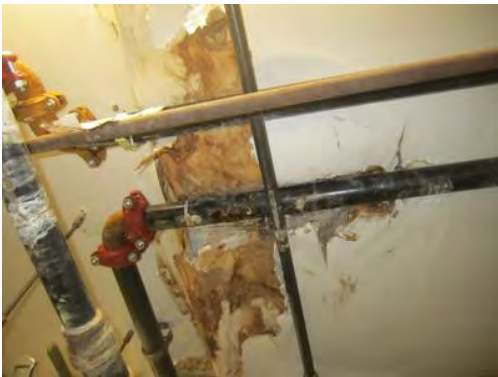
Concrete Wall Detail - Boiler Rm

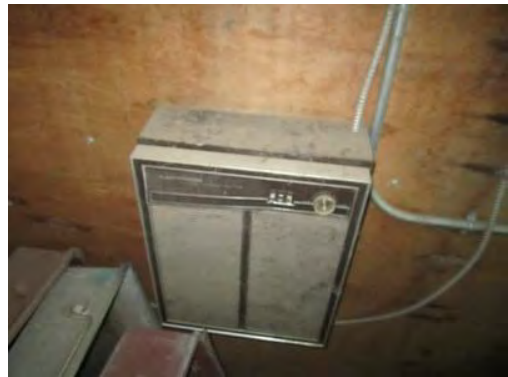
Electric Unit Heater - Pesticide Store

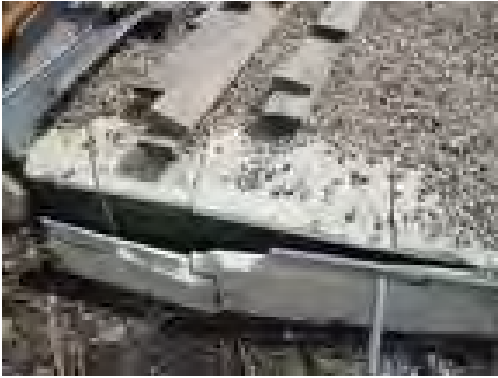
Ext Roof Insulation Detail - South

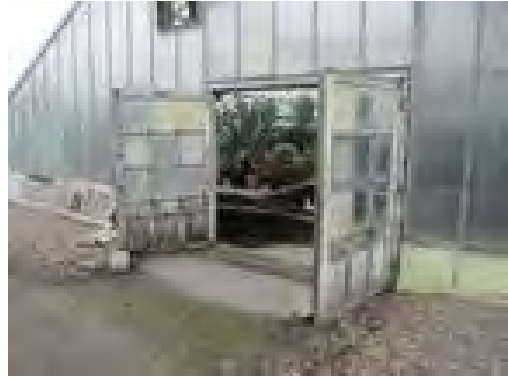
Ext Wood Poly Glass Doors - East

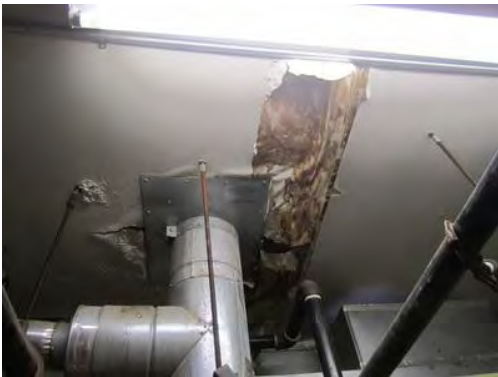
Gypsum Board Ceiling Detail - Boiler Rm

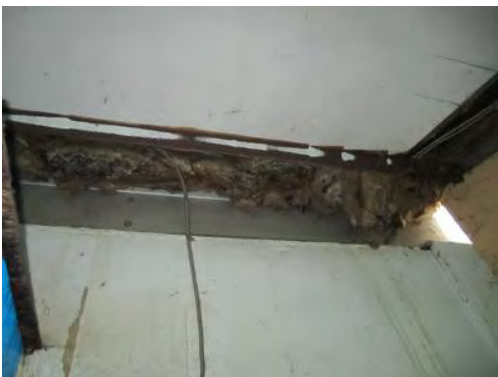
Int Insulation Detail - Pesticide Store

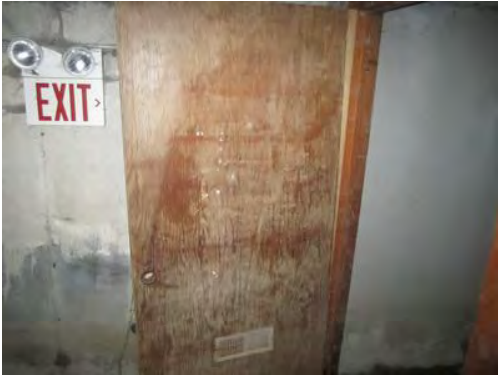
Int Wood Door - Basement

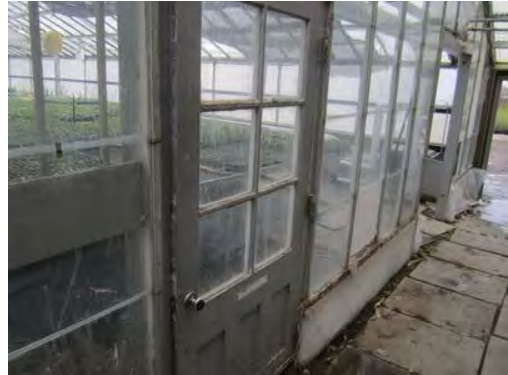
Int Wood Door - Greenhouse Corridor

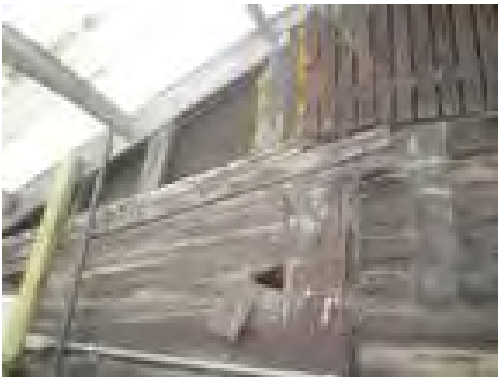
Int Wood Wall Detail

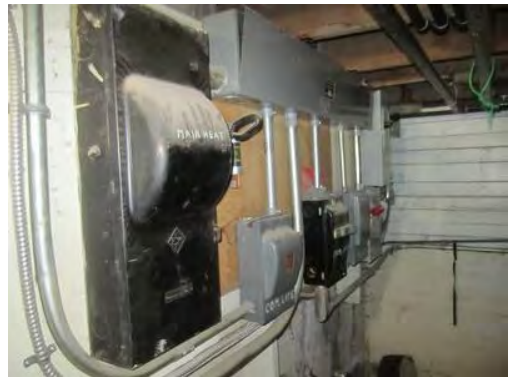
Secondary Distribution - Basement

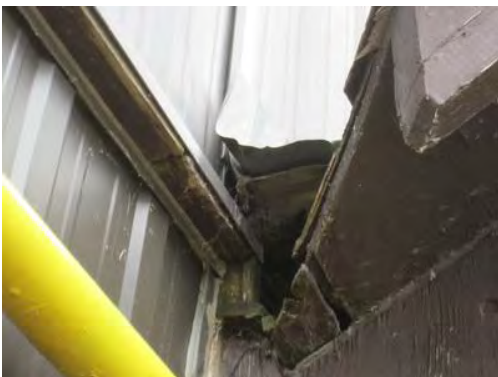
SM Roof Detail - North

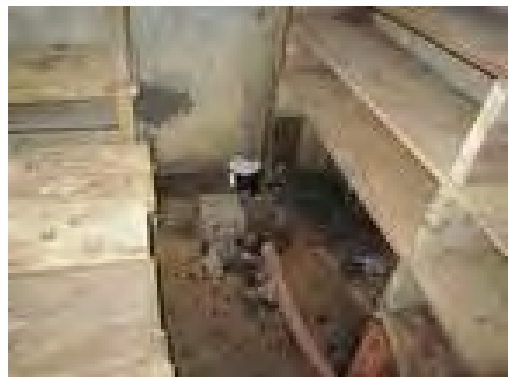
Sump Pump - Basement

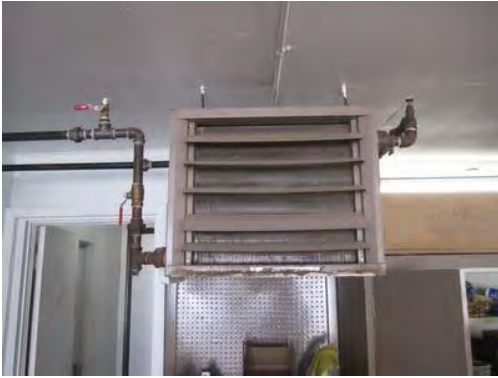
Unit Heater - Garage

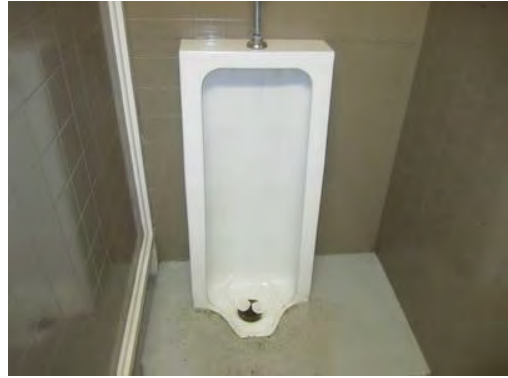
Urinal - Staff Washroom

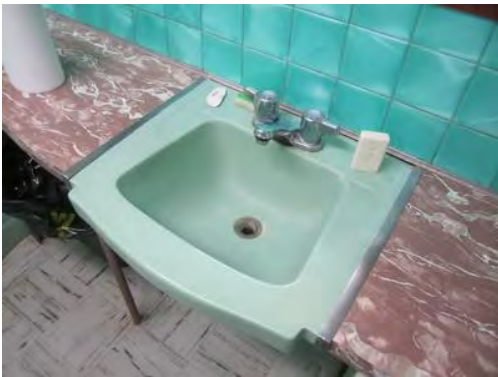
Vitreous China Sink - Women's Washroom

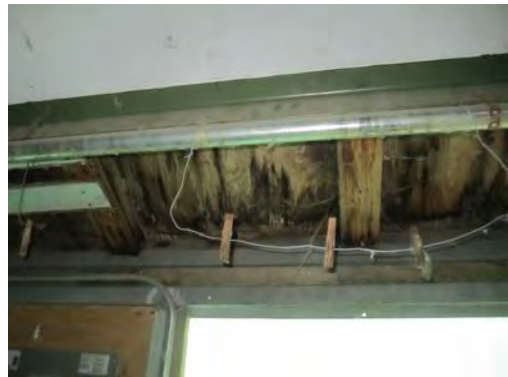
Wood Ceiling Detail - Pesticide Store

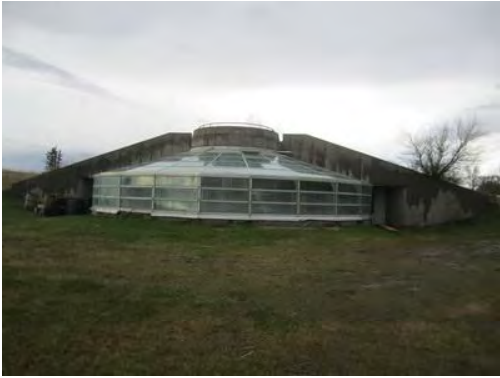
South Elevation

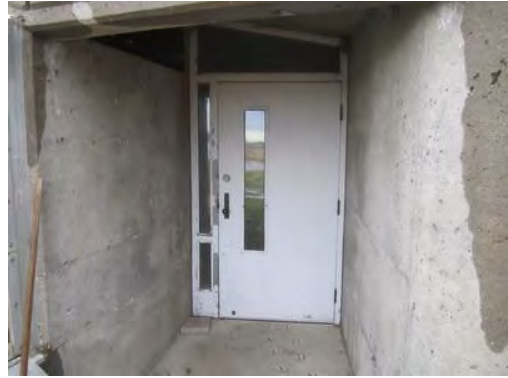
Ext Steel Door - South

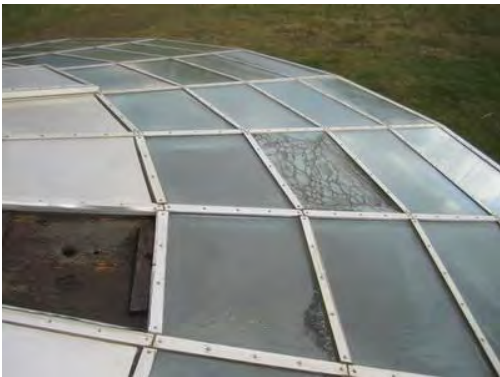
Ext Roof Glazing - South

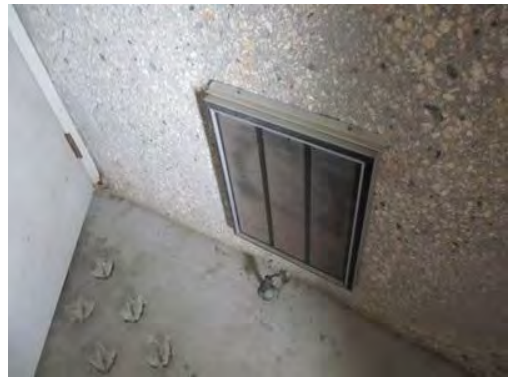
Electrical Unit Heater

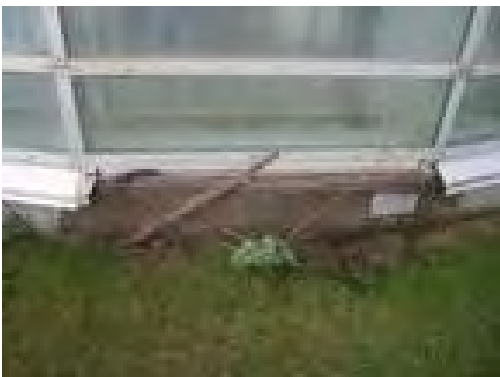
Ext Sheet Metal Flashing Detail - South

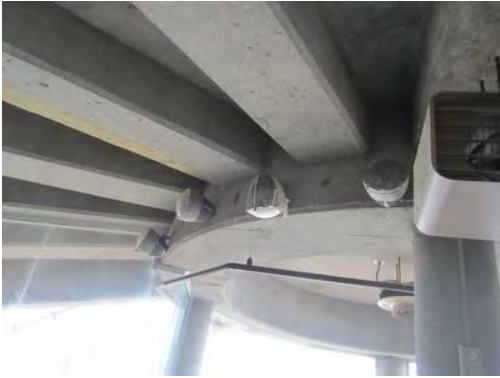
Int HID Lighting
